14 CFR Part 39

[Docket No. 95-NM-22-AD]

Airworthiness Directives; Boeing Model 747-100, -200, -300, and SP Series Airplanes**AGENCY:** Federal Aviation Administration, DOT.**ACTION:** Notice of proposed rulemaking (NPRM).

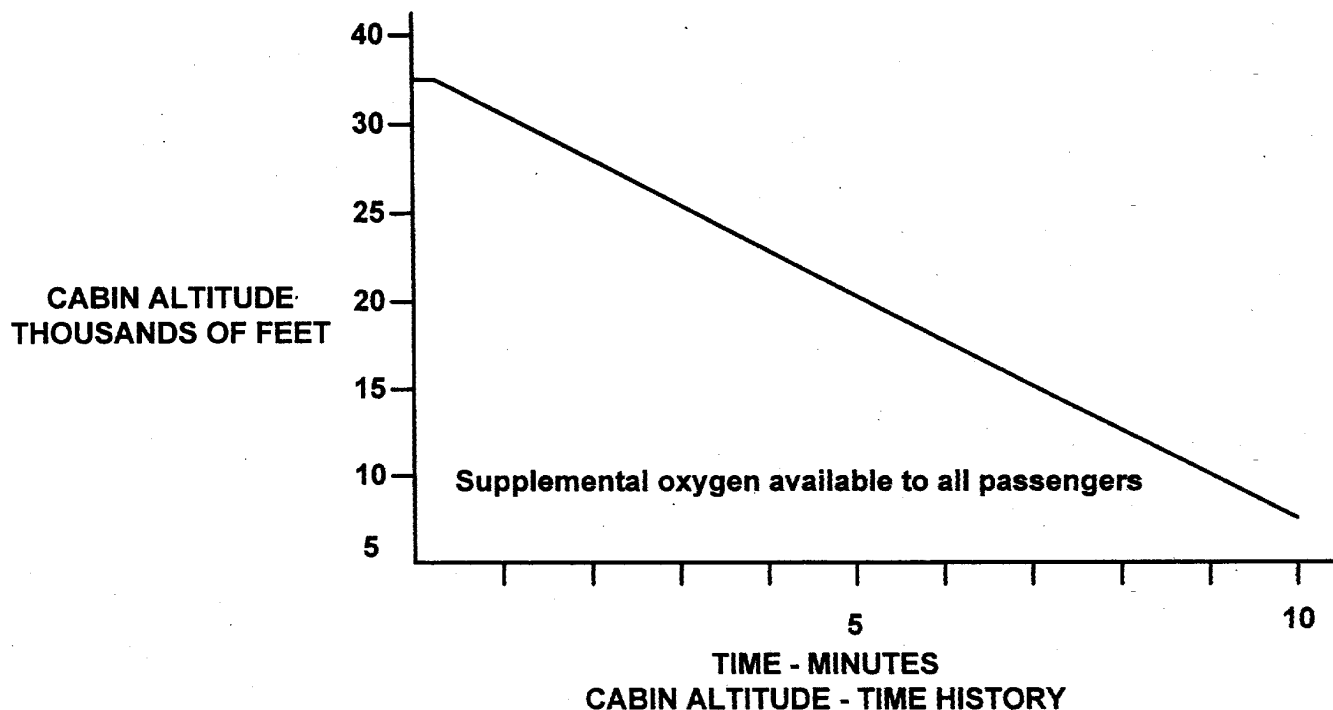
Figure 4

NOTE: For figure 4, time starts at the moment cabin altitude exceeds 8,000 feet during depressurization. If depressurization analysis shows that the cabin altitude limit of this curve is exceeded, the following alternate limitations apply: After depressurization, the maximum cabin altitude exceedence is limited to 40,000 feet. The maximum time the cabin altitude may exceed 25,000 feet is 2 minutes; time starting when the cabin altitude exceeds 25,000 feet and ending when it returns to 25,000 feet.
